Classification of Main Faults in the Production Process of Extruded Aluminium Profiles

Hasan Al-jabbouli¹, Ebubekir Koç², Yaşar Akça³

ALUTEAM, Faculty of Engineering - Architecture, Fatih Sultan Mehmet Vakıf University.

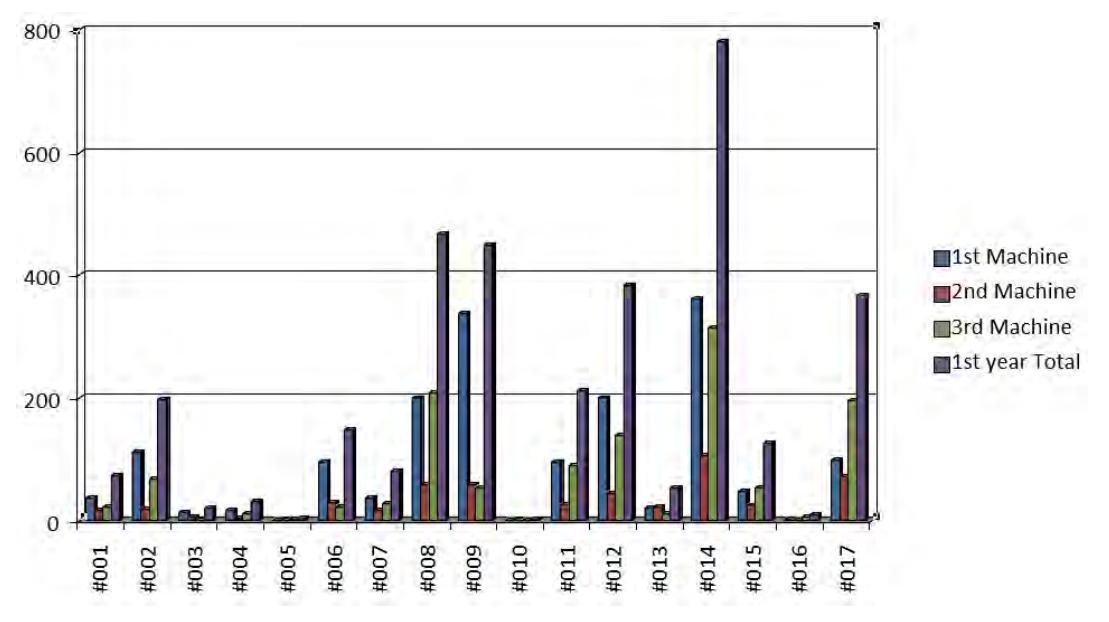
Fig. 3. The number of occurrences of faults during 24 Months for each machine

Frequencies of the occurrence of these faults and defects for each machine during monitoring period are shown in Fig. 3. While Fig. 4 shows the percentages of these faults and defects.

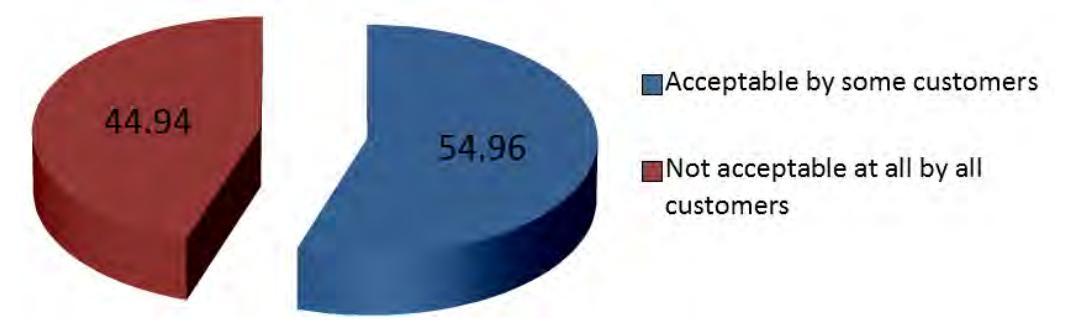
Fig. 5. The percentage of occurred faults according to their acceptance by customer

Fig. 5 shows the percentage of occurred faults according to customer satisfaction and according to their type. As can be seen, not all faults are critical for marketing side. Some faults can be acceptable for some customers; also some faults can be corrected in the post-extrusion processes like painting or anodizing.

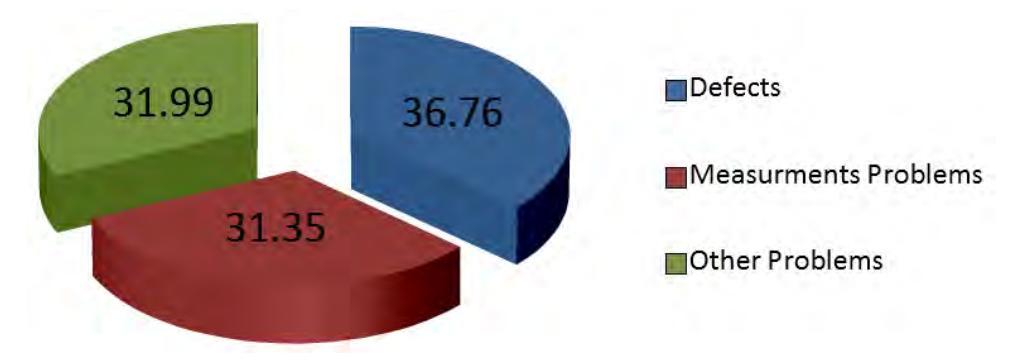
Fig. 6. The percentage of occurred faults according to their types

In Fig. 6, the percentage of occurred faults according to their types is presented. Faults can be classified into two sets since profiles are designed in cross-sections and extruded to create a surface. Defects occur on surface and measurement problems occur on cross-sections; other problems are also related to these two sets but cannot be classified under these groups because of their different shapes and reasons of occurrence.

Defects and measurements problems have high percentage of occurrence. This can be explained due the lack of using automated detection techniques and because of the reliance on human detection all the time with poor training for workers. It is strongly recommended to use machine vision technology to detect these defects online at early time, to increase the training for workers especially about the faults mentioned in Table II and to be sure of applying regular maintenance for machines with clear regulations.

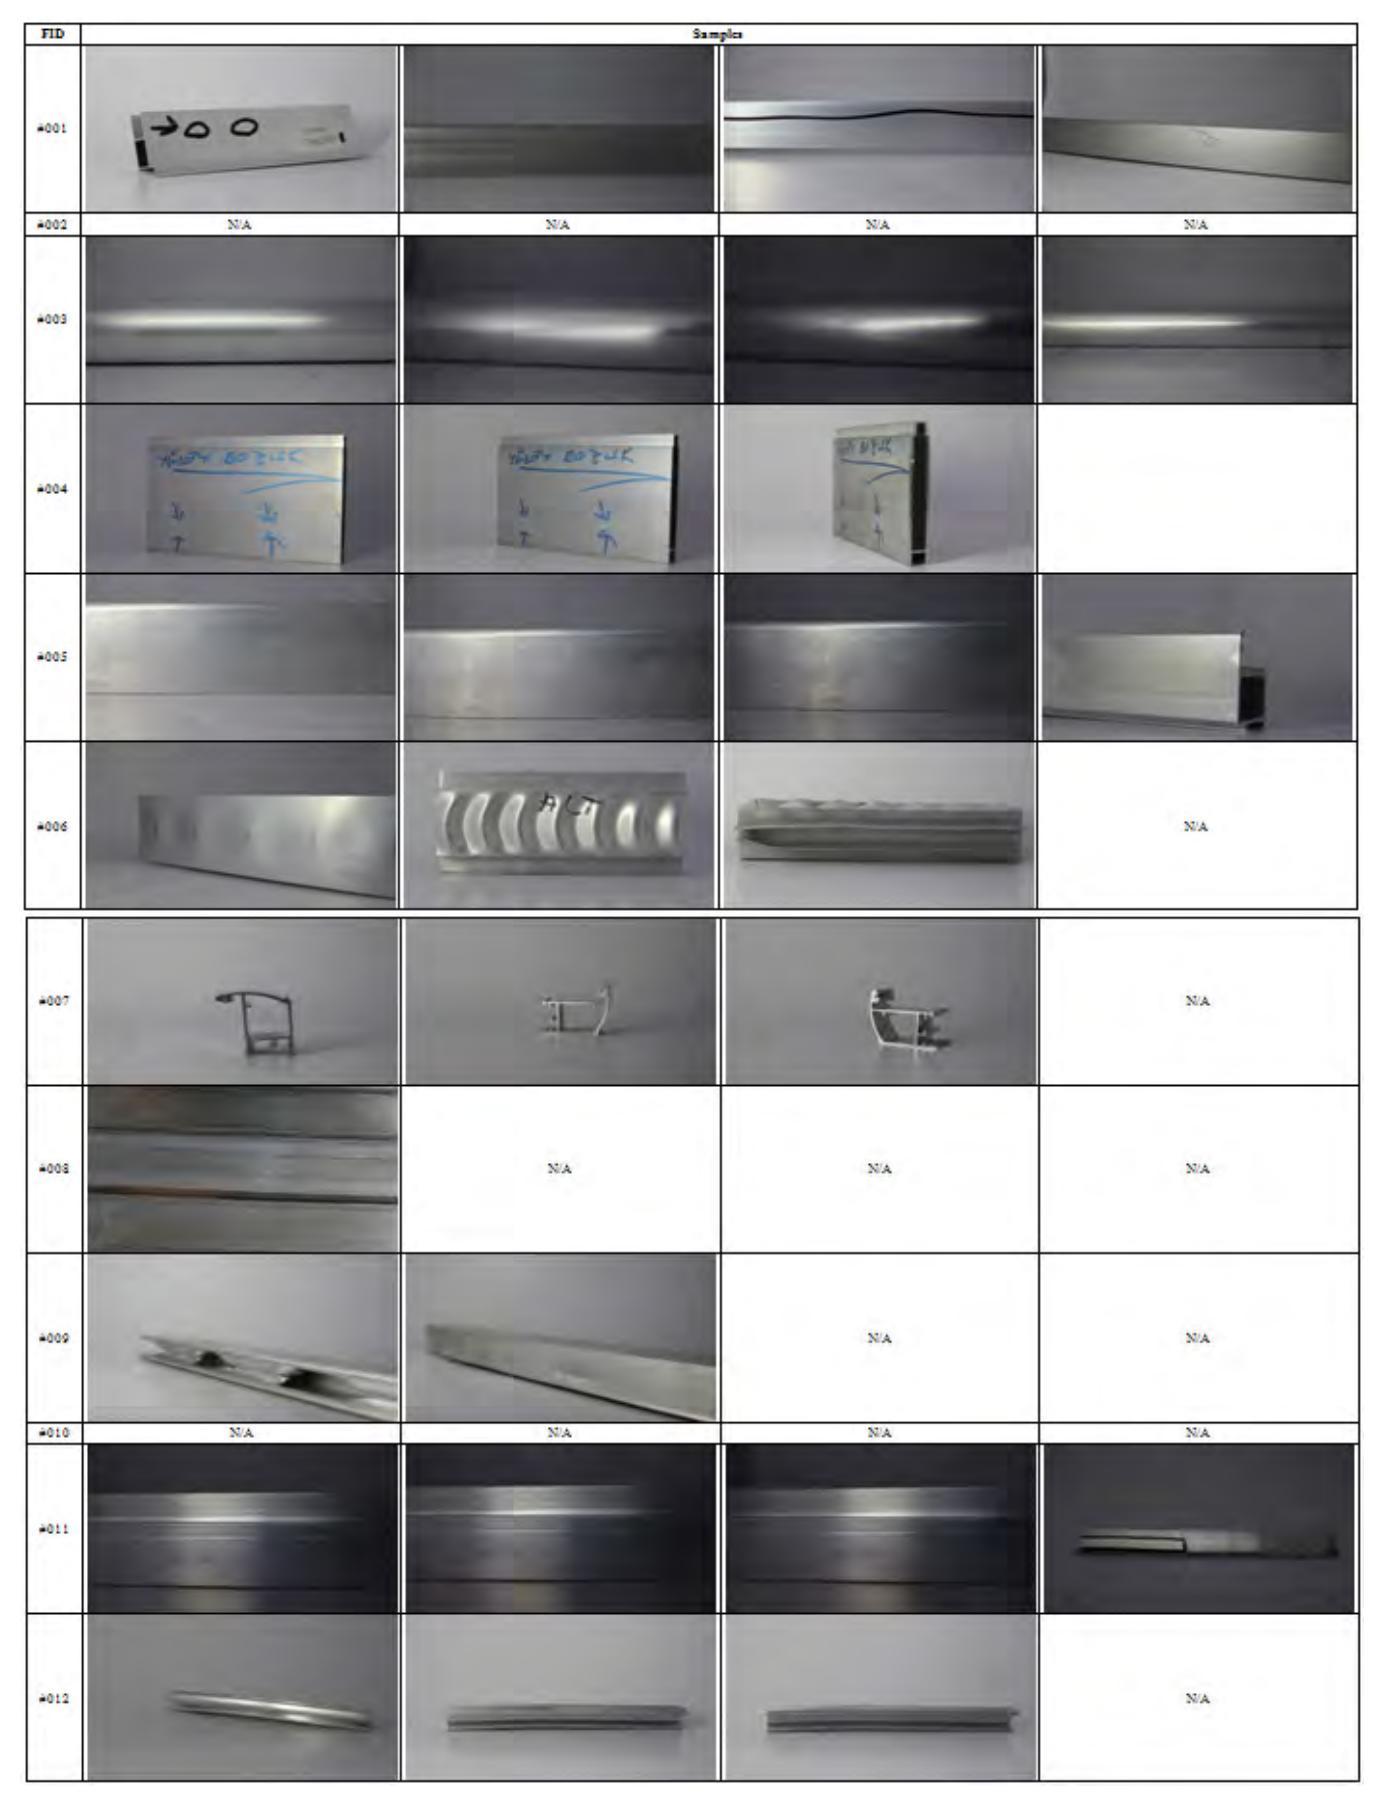
TABLE III - Defects Photos

Fault ID	Status	Fault Description	Reason
#001	NA	Some bins or holes can be seen on the profile surface	Arrival of foreign material to the mold which means that the row material is not clean

#002	NA	No output out of the mold	Die or aluminum ingot is not heated enough or the extrusion machine is not working in a good way (may be broken or no electric)

#003	NA	Parallel lines on profile surface	Something is scratching the surface of the profile
#004	NA	White and black line color (could not be seen before Anodizing)	There is a high temperature in both of the profile and the die

#005	MbA	There is some color change on the surface of the profile (gray color like a line) which is unseen before Anodizing.	Temperature problem: there is a difference in temperature of some areas on the profile surface.

#006	NA	Wavy Profile Shape.	Very high pressure (profile is going very fast) and there is a problem in the flowing of aluminum through the die.
#007	NA	Inaccurate outputs, some parts of the desired profile are filled with extra aluminum or are missing aluminum.	Aluminium flowing is not good through the die or the die is broken

#008	NA	The whole surface is curved.	Die is not accurate, the die should be replaced.
#009	NA	Some sides of the output profile are coming out of the die faster than others	The flowing of material throw the die is not good.

#010	NA	Producing rotated profiles	The bolster which holds the die is not fixed properly or the flowing of material throw the die is not good
#011	MbA	Vessels, Pulling (like a barrier) or Tearing on the profile surface	Bad row material, bad die coating or bad polishing for the die surface

#012	MbA	Profile dimensions are incorrect (out of tolerance), Edges are wider or thicker compared to the wanted design in some areas (not accurate)	The flow of aluminum varies in the different sides of the profile or the die bridge is not located correctly or Die design problem or wrong centering of extrusion system (die, punch and exit hole) by Machine operator or applying high pressure

#013	NA	Horizontal line across the profile	The die is moving and not fixed correctly or the mold has deflected
#014	MbA	Damaged surface which is like a tiny scratch along the surface.	Die coating is not correct or has finished

#015	MbA	Some edge parts of the profile are raised up or fallen down in some cross sections.	Die design problem or wrong centering of extrusion system (die, punch and exit hole) by Machine operator or applying high pressure

#016	NA	incorrect Profile (different output compared to the design - sometimes upside down)	The wrong combination of a set of molds by operator
#017	MbA	Post-extrusion mistakes (not related to machine)	Handling Error due to bad cutting or pulling problem or dirtiness
